## Minerals Inspection Report

Mine Name: Copperton Concentrator	Permit Number: M/035/0011	Mine Status: Active
Operator Name: Rio Tinto - Kennecott Utah Copper	Inspection Date: August 21, 2013	Permit Fees: Paid
Inspector(s): L Heppler, A Abate, T Nicolaysen	Inspection Time: 9:00 AM	Bond Amount: \$ 23,904,400
Attendee(s): T Lindsay, T Heaton	Weather: Sunny, Dry	Bond Escalation: 06/22/2014
Inspection Purpose: Routine annual inspection		Prior Inspection: May 10, 2012

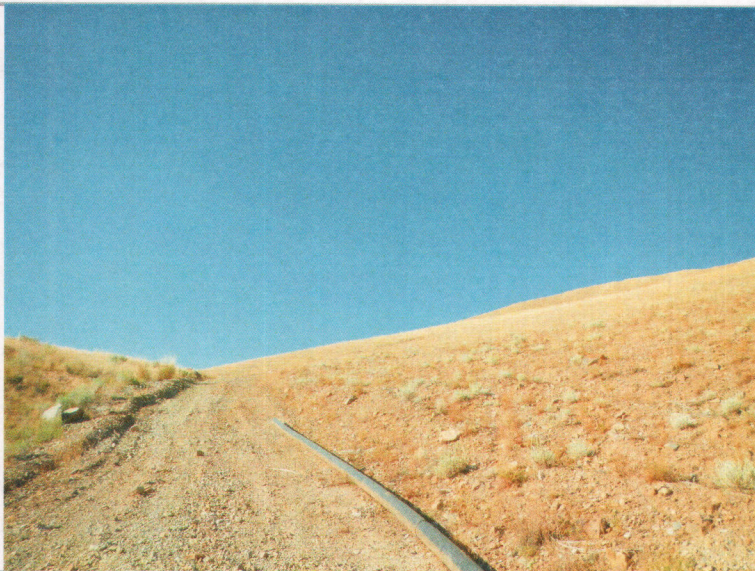
2. <i>Public Safety (shafts, adits, trash, signs, highwalls)</i> Mine site is accessed through a paved road and a full time manned secure entrance. No trash was noted on site. New cut slope have been vegetated	<input checked="" type="checkbox"/>	<input type="checkbox"/>

Slope west of ore sorter - note vegetation

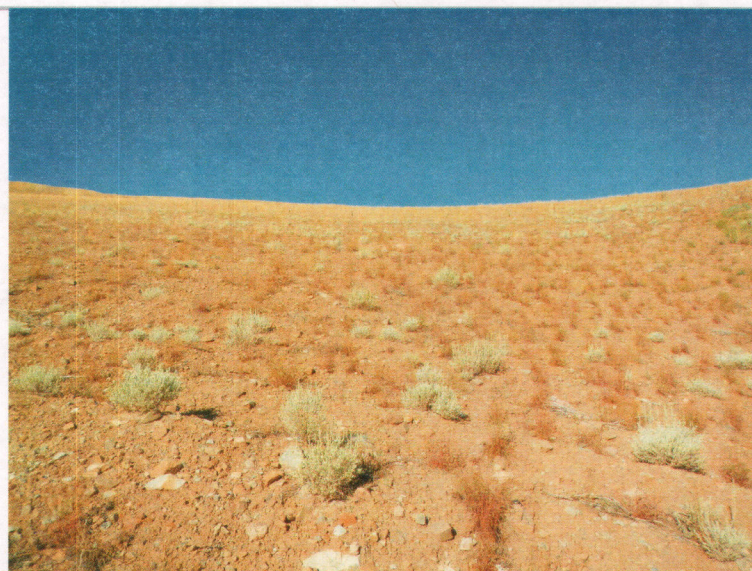
Slope west of ore sorter - note vegetation

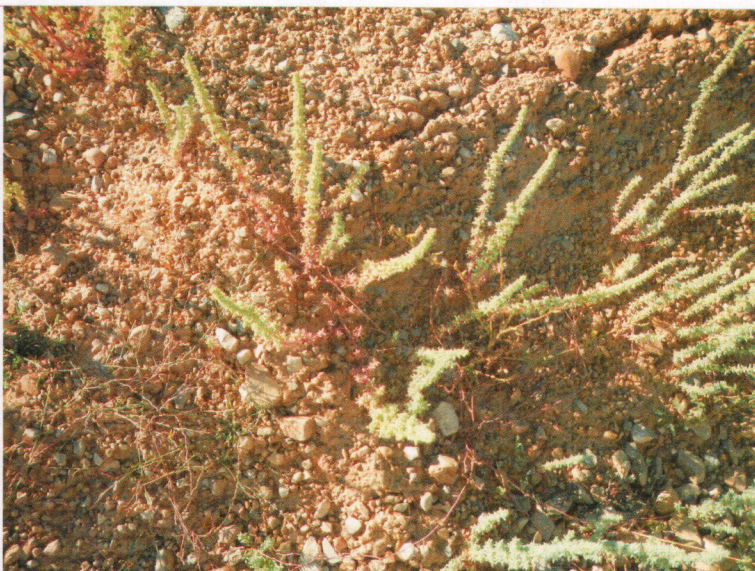
8. <i>Soils</i> No soil stockpiles are noted at the time of inspection.	<input checked="" type="checkbox"/>	<input type="checkbox"/>
9. <i>Revegetation</i> Vegetation is limited to a variety of forbes and grasses. At this time most areas are asphalt pavement, but a few weeds are noted.	<input checked="" type="checkbox"/>	<input type="checkbox"/>

Halogeton

Updated NOI needs to be submitted with bond calculation. A weed control program should be implemented along the perimeter area of the concentrator, this area is very limited as the overall site is dominantly asphalt pavement. OGM to continue annual inspections and monitor the site when in the area.

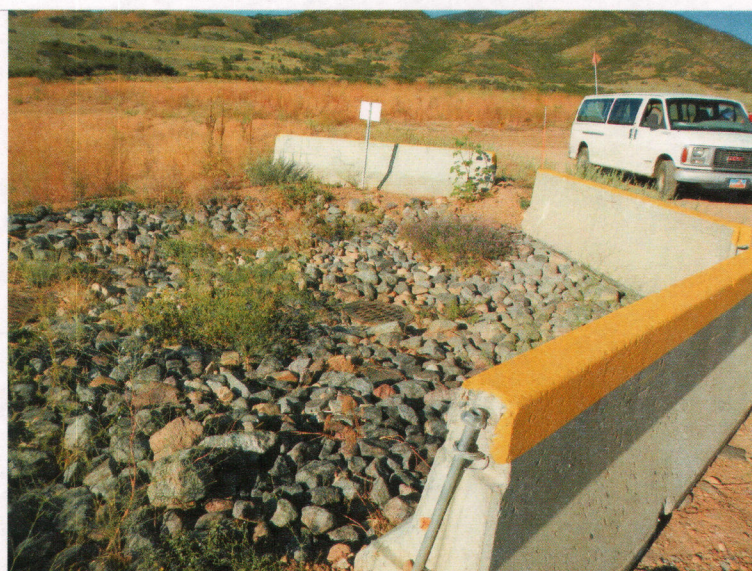
Riprap apron

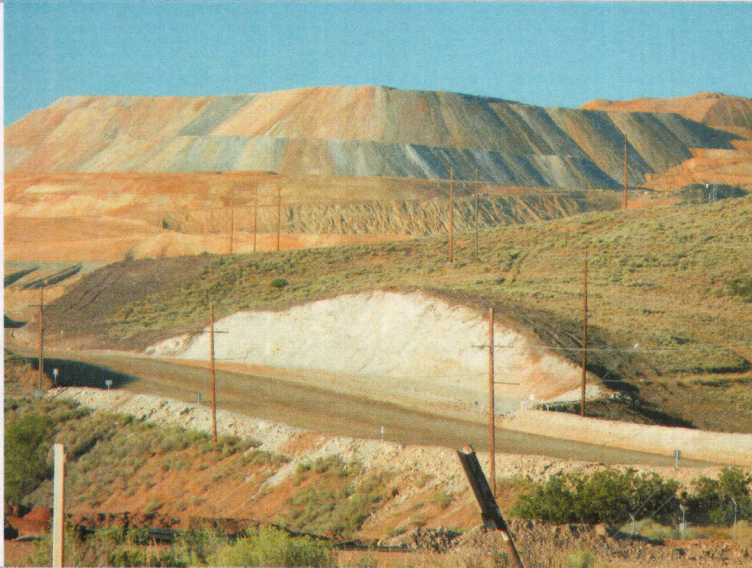
Cut slope with haul road widened in 2013

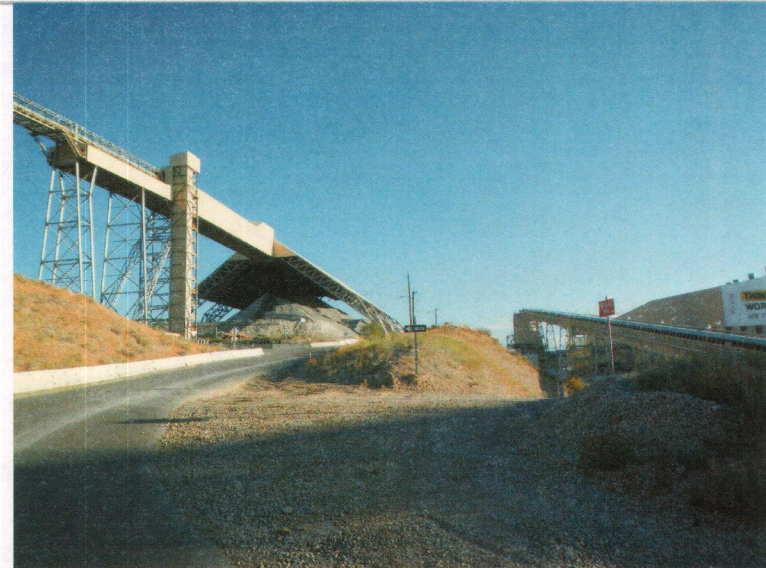
A Frame - Ore stockpile

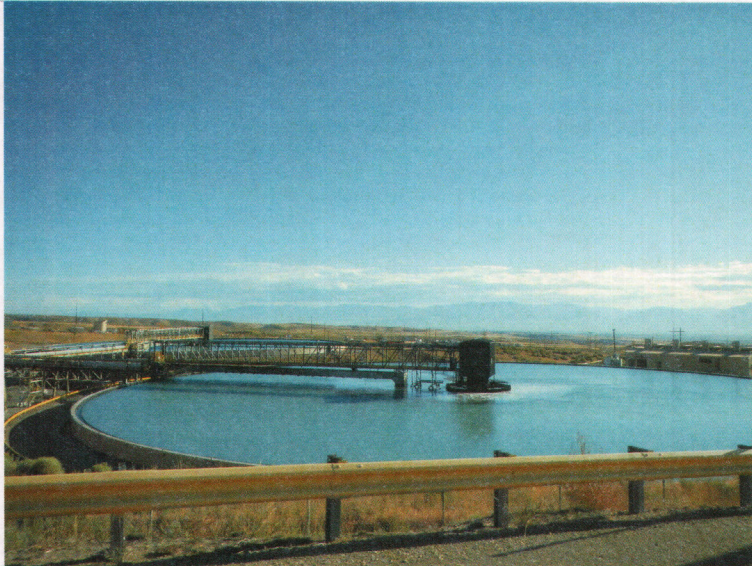
Tank

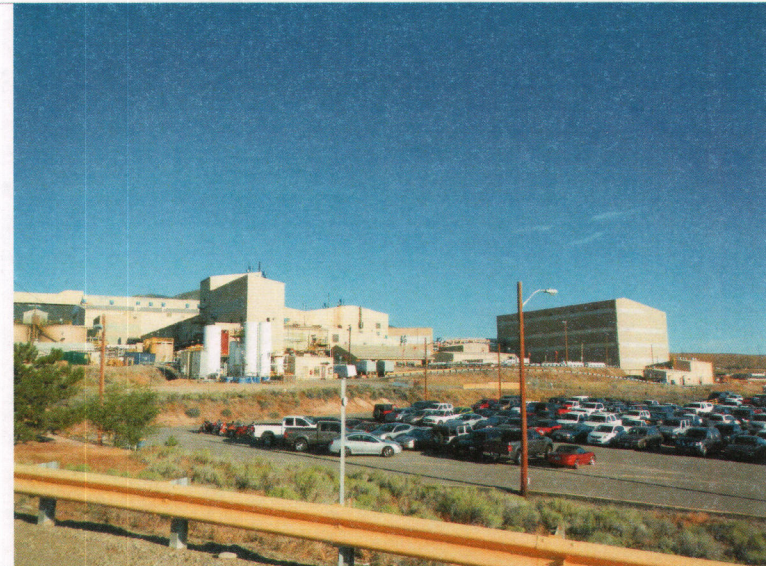
Concentrator building
